F-1-202
Hebb-Kline Farmstead
Adamstown vicinity
Private

F-1-202
Hebb-Kline Farmstead
Adamstown
Frederick County

Maryland Historical Trust State Historic Sites Inventory Form

MARYLAND INVENTORY OF HISTORIC PROPERTIES

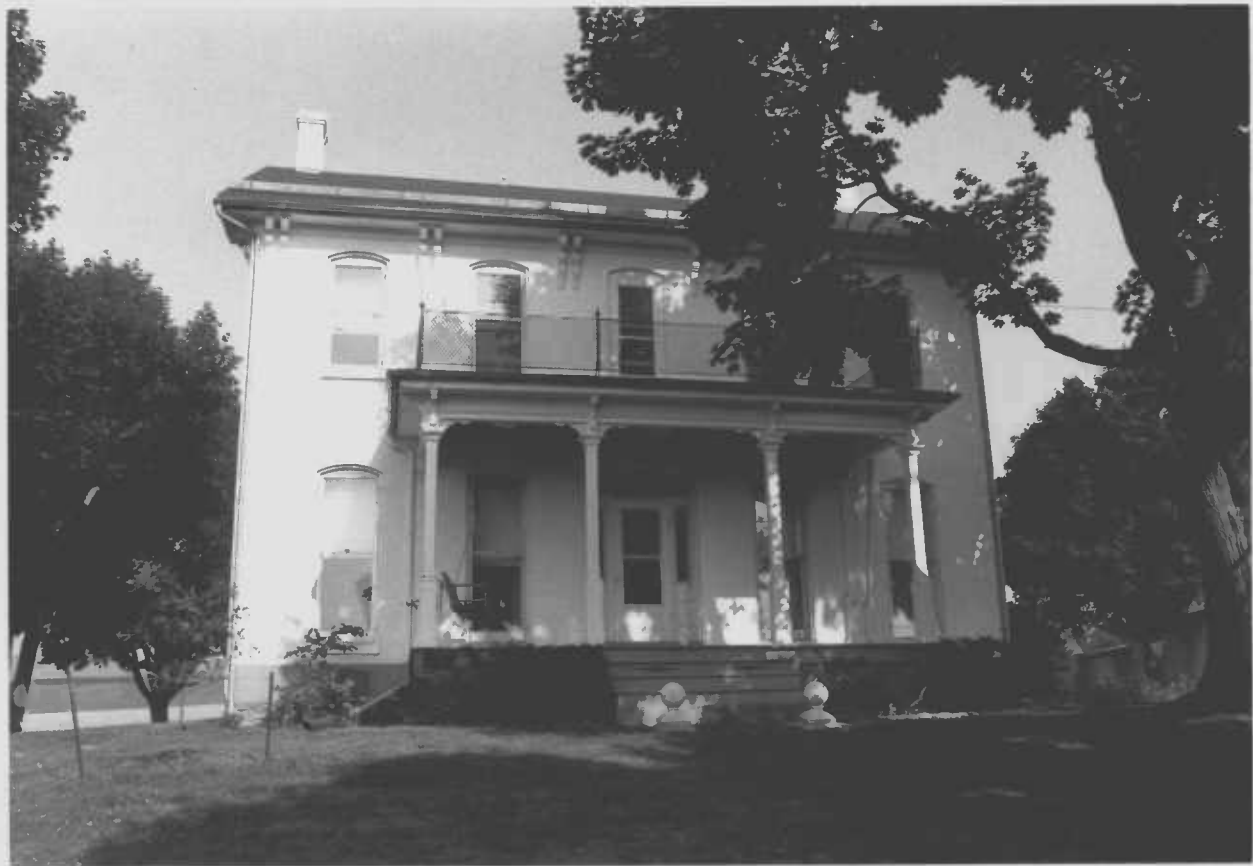
1/4

Southeast elevation

The white-painted dwelling has a five-bay south elevation on the main section and a two-story rear wing extending from the middle of the north elevation with one-story porches on both the east and west sides. The south elevation has a one-story porch over the central three bays. The window and door openings have segmental arches and 1/1 sash. The first story windows are tall and narrow, reaching almost to the floor of the porch. The doorway has a two-light transom and sidelights. The porch has scrolled brackets and chamfered square posts with a wood deck. The flat roof of the porch has an iron mesh fencing along the top and the center second story bay is a small door opening on the porch roof. The main cornice of the house has extended eaves and paired brackets which extend on all elevations of the front section. The wing has single brackets in its cornice. The north and south elevations have two bays each with small attic windows. The composition roof was probably wood shingles or slate in its original form. The interior end chimneys are still intact. The rear wing has a single interior chimney near the center of the section. The east and west side porches have scroll-sawn brackets and balustrades. The porch on the south side has a concrete block base below the deck. The north side has an enclosed section at the west end of the porch, with a 2/2 window. This was probably the original sash configuration of the entire house. The interior was not accessible for this survey.

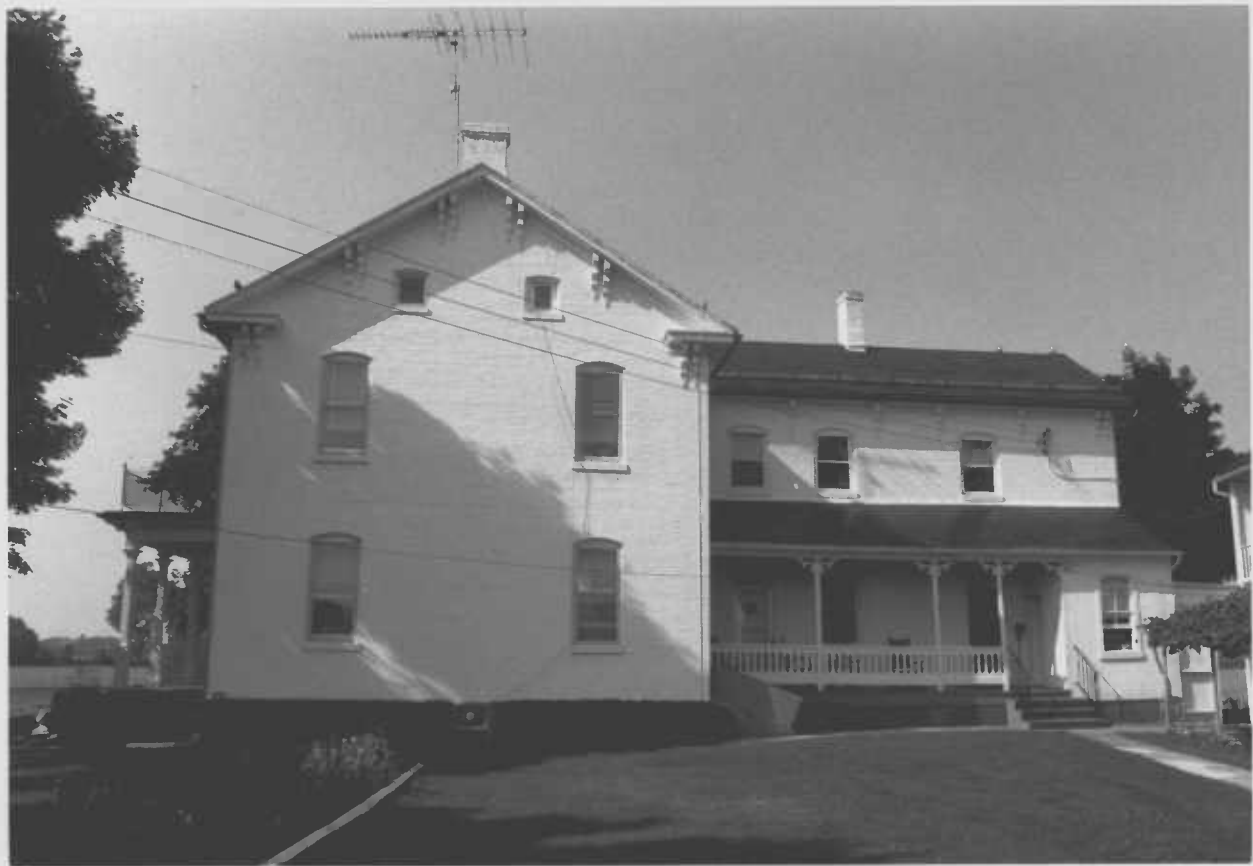
2/4

North elevation

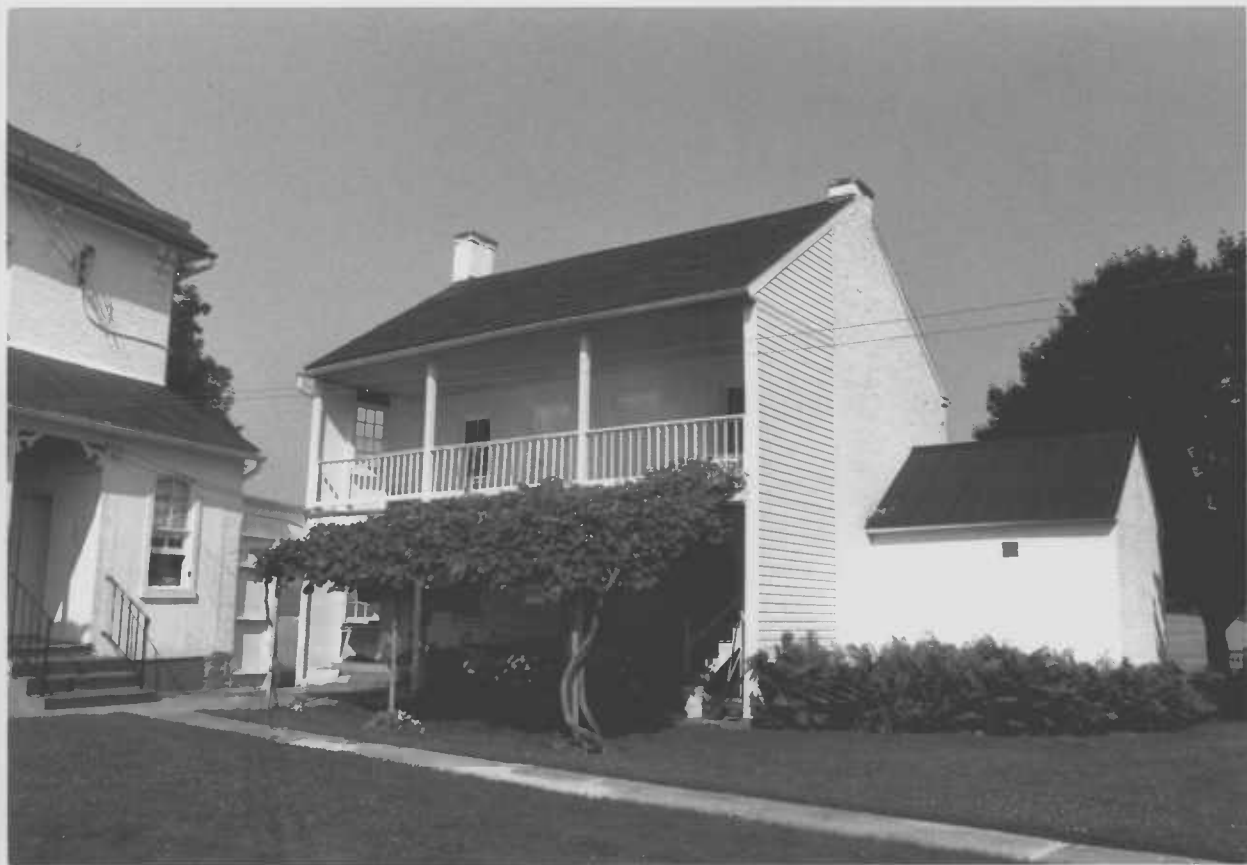
3/4

Tenant house / smokehouse, east elevation

Summer kitchen/smokehouse: The term summer kitchen may be an understatement of the original intent of the structure. This outbuilding resembles a free-standing rear wing as found on mid-19th century houses. It is only slightly lower in height than the rear wing of the dwelling. Its brick structure has an integral two-story porch on the south side and interior end chimneys. There are three bays on the first story and four on the second. The upper porch has a plain balustrade and square posts. The roof of the building is composition. The sash is 2/2. On the north elevation are three bays on the first story and two on the second. The cornice is corbeled. Attached to the summer kitchen on the east gable end is the one-story brick smokehouse. It has a standing seam roof and a single vertical board door on the north. At the east gable end is a pierced brick vent in the wheat sheaf pattern often seen in brick barns. The interior of the summer kitchen was not accessible, but observation of its interior features may reveal more about its purpose and

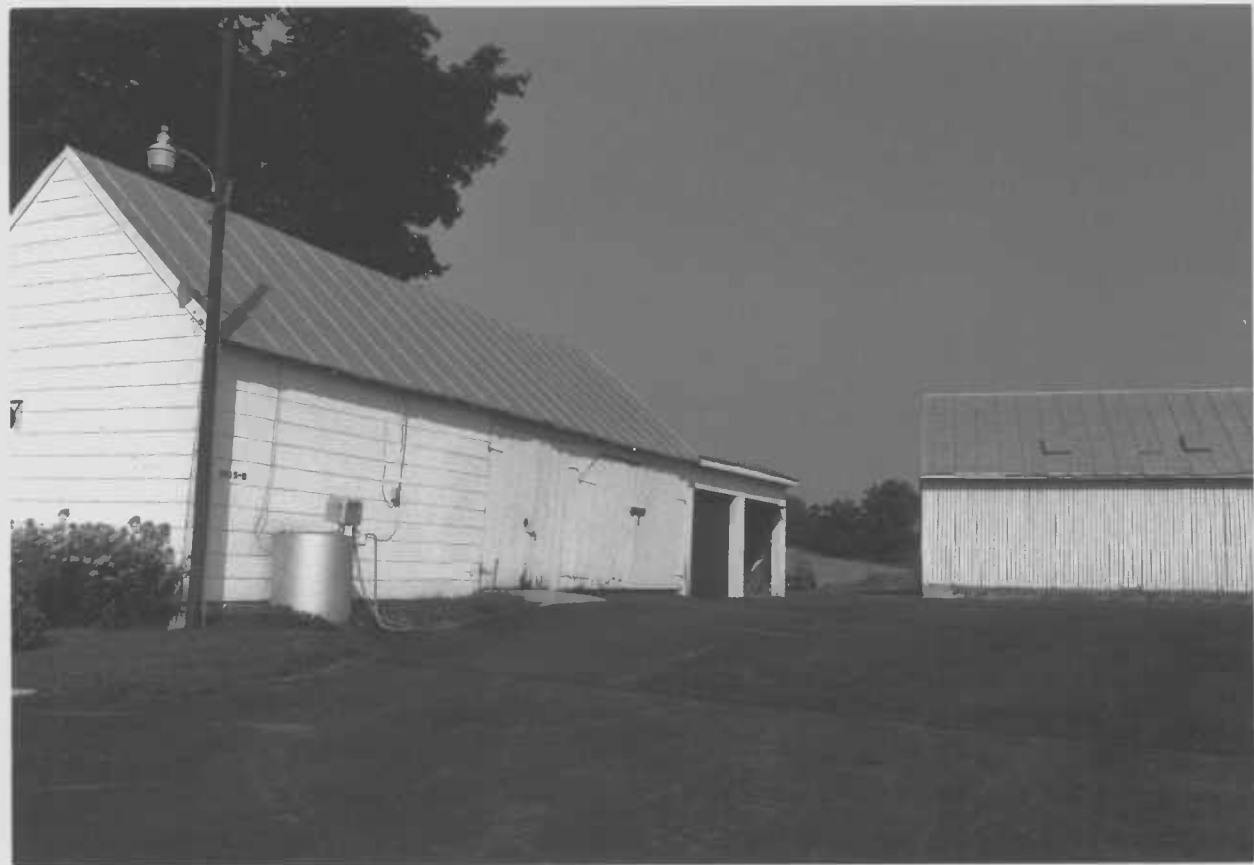
4/4

Garage and wagon shed/corn crib, view from
east

Frame sheds: The frame sheds are located around a paved driveway termination east of the house. Non-contributing concrete block dairy and other agricultural buildings border the east side of the driveway from near the entrance on Mountville Road to this termination. The rectangular frame building on the south side of the paved area is partially covered with asbestos shingle siding with a vertical board section at the north end. Two sets of double swing doors are located near the north end and the building is adjoined by a shed roofed double bay garage of concrete block with open passages on the east. The roof of the larger section is standing seam metal and the shed roof on the concrete block garage is corrugated metal. The sheds probably span a period dating from about 1890 to 1920.

Wagon shed/corn crib: The frame wagon shed is at the north side of the paved area. It has corrugated metal siding on the west elevation and vertical siding on the east, with sliding doors to close off the drive-through. The north and south sides of the crib have vertical lath strips. The roof is standing seam metal. The wagon shed may date from about 1890.
